Mi8, Mi17 and Mi24/35 Helicopters

Improving Reliability and
Availability

Application bulletin

Problems with Helicopter Operations in Desert Conditions

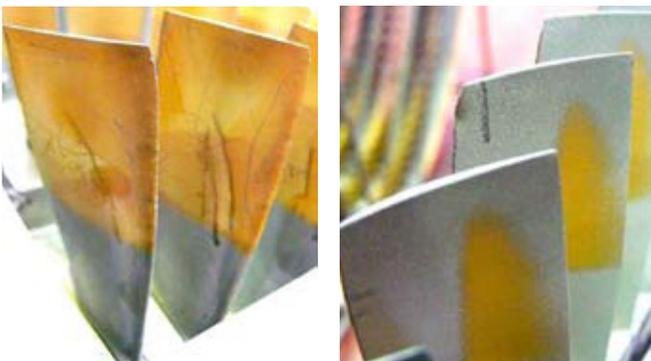
Reason for premature removal of TV3-117 engines*	%
Compressor blade erosion	35...40
Damage to compressor or turbine ducts	20...25
Nicks on compressor or turbine blades	15...20
Compressor stall or surge	10...15
Foreign object damage	5...10
Others	0...5

Compressor Blade Erosion

The fit and forget *PUREAir* system is the optimum solution for such challenging operations. It will **solve all the above reasons for premature engine removals** and offers the following benefits:

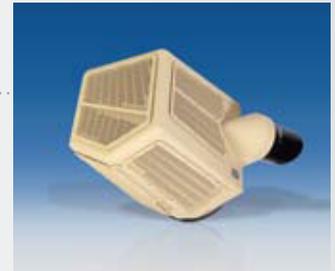
PUREAir for Mi24 and Mi35 helicopters

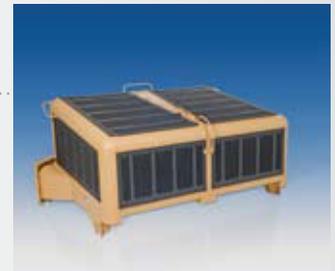
PUREAir for Mi-8 and Mi-17 helicopters

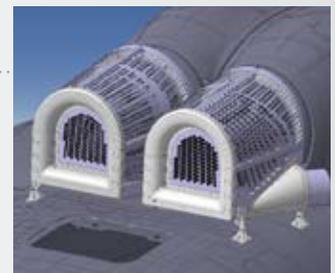
PUREAir for Mi-171 helicopters

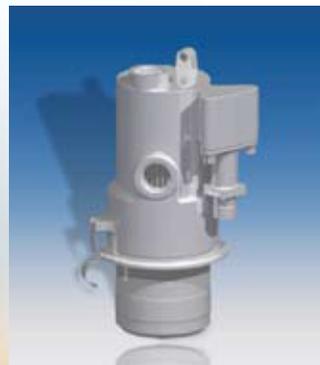
TV3-117 Engine Lube System

The current fuel and lube filtration on the TV3-117 engine consists of cleanable, wire mesh filters (not supplied by Pall) which are not effective in contamination control. These filters have a low particle removal efficiency and a limited dirt holding capacity and quickly become clogged. **For the TV3-117 engine, Pall Aerospace has designed filter upgrade kits** that provide disposable, finer filtration.

These 'depth' type, disposable filter elements provide finer filtration with a high dirt holding capacity which reduces the number of filter blockage incidents. They eliminate the logistics and labour costs associated with ultrasonic cleaning of metal mesh elements. In addition, they eliminate the 'human factor' in achieving consistent quality in the maintenance and cleaning procedures. The filter element service life is expected to be 3-5 times longer than the existing metal mesh filters (hence less maintenance and system openings to atmosphere).

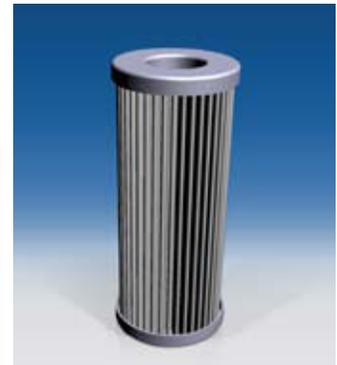
TV3-117 Engine Fuel Filter

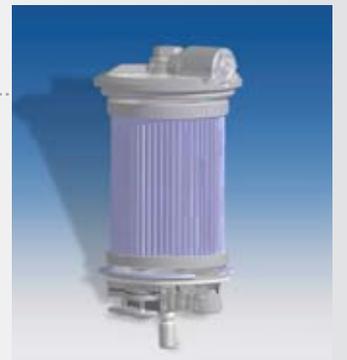
The upgrade kit includes a 15 micron disposable filter element that is very efficient at cleaning up the transmission gearbox. The kit is qualified for both gearboxes; VR-14 (Mi-8/17 helicopter) and VR-24 (Mi-24/35 helicopter), and consists of spare filter elements, valve unit (incorporating by-pass and shut-off valves) and filter cavity cap with filter clogging indicator.

Main gearbox lube filter kit

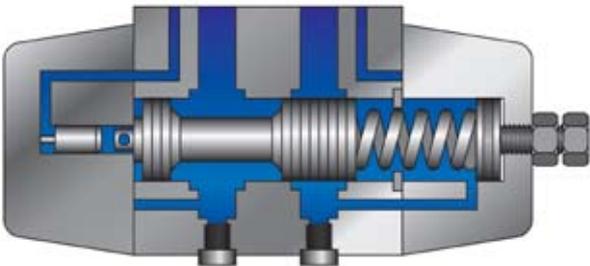
Dust and contamination will cause scoring, scratching, wear and corrosion and this degrades the hydraulic system performance.

Typical Valve Assembly.

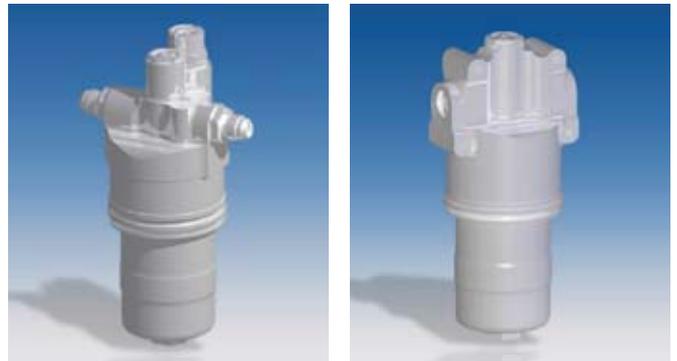
Mi8/17 Hydraulic filter assemblies

For the latest generation of Mi-8/17 family (Mi-171A2), a new hydraulic filter assembly and a reservoir breather are being introduced by Pall Aerospace. They are also available to retrofit the existing fleet.
